**US Army Corps
of Engineers**

USACERL Technical Report 99/28
February 1999

Engineering Life-Cycle Cost Comparison Study of Barrier Fencing Systems

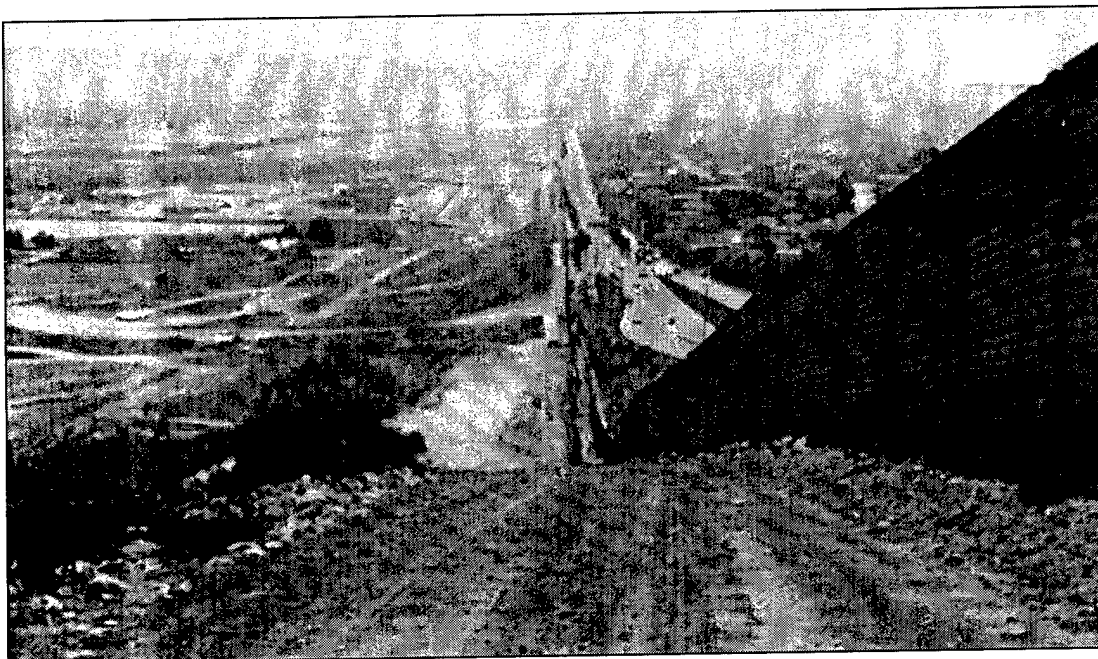
Figure B.14. View of the flat ground west of the San Ysidro border entry point.

Figure B.14 shows the flat region between the San Ysidro border entry and the hills. The United States is to the left of the fence, and a sewage treatment plant is visible in the distance. The secondary bollard fence will be installed on the lower terrain 100-ft north and at a 30-degree angle to the primary fence. The closeness of the Mexican highway and buildings to the fence is apparent. The flat ground and proximity to San Diego's southern suburbs make this a high traffic area for illegal immigration. The ground shown in Figure B.15 will become a retention pond. North of the sewage treatment plant is the maintenance base camp. The fence continues to the Tijuana levee.
